BOLTON CONSERVATION TRUST

BOLTON LIMESTONE QUARRIES & KILN

A Brief Description of its History, Geology and Workings

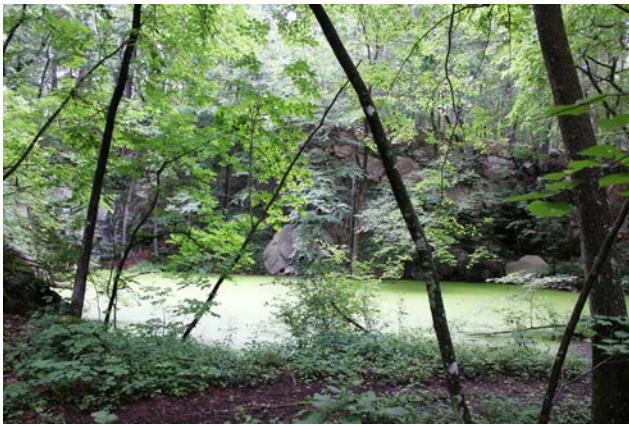
Whitcomb Quarry

Limestone was excavated from two quarries, the Hildreth Quarry to the south and the large Whitcomb Quarry to the north. Quarrying of the Hildreth Quarry, the older line of near-surface excavations, involved hand tools (star drills to drill holes to split rock with “feathers & wedges”). Consequently, when harder dikes of scapolite rock were encountered, they were left in place and the limestone was removed around them. The dikes are still clearly evident today.

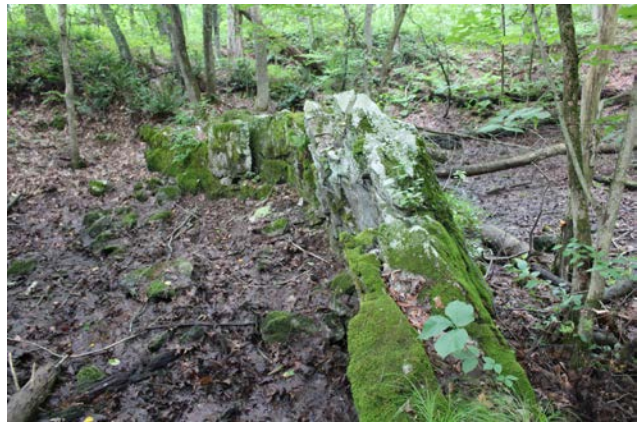
Hildreth Quarry with scapolite dike

1. The very hard scapolite layers between the limestone deposits became vertical during metamorphosis, forming 'dikes' which were difficult for the early quarry workers to cut and consequently were left in place, the softer limestone being removed all around them. They may still be seen standing, appearing much like walls, in the older quarries.
2. Dynamic metamorphosis in which rocks are broken and ground without much hardness, density or crystal change. Cracks in the rocks (faults) may be seen in the east wall of the largest quarry.

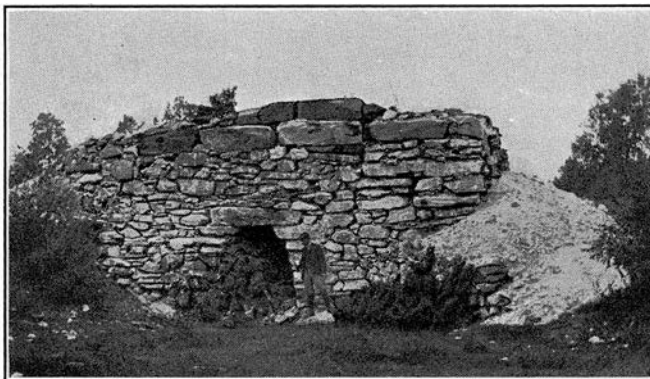
Lime Kiln – 1938 (History of Bolton)

The kiln used to convert the limestone to lime was set into the hillside to the east of the Whitcomb Quarry. In the 1950's the rock lintel to the doorway failed and the front face collapsed. The lime kiln was restored to its original configuration in 1976 on the basis of an old painting and a photograph in History of Bolton (1938) with funding through a Federal Government US Bicentennial Grant.

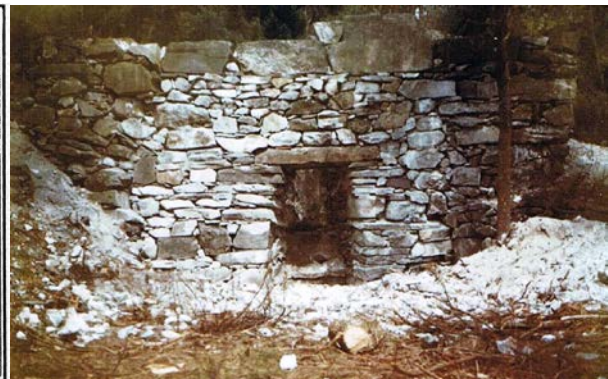
Lime Kiln – 1976 (after reconstruction)
