# Bolton Trail Safety and Connectivity Initiative

#### Problem statement

### Photos of Bolton Trail Crossings

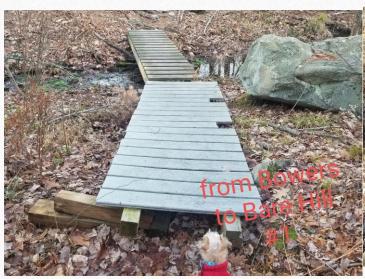
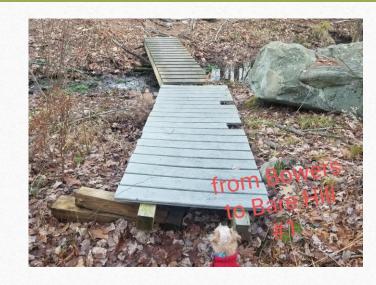
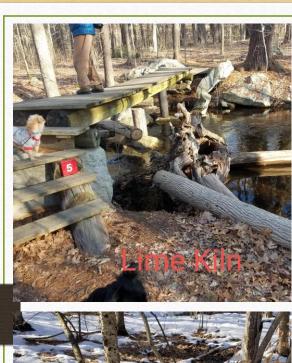
- Bolton has 14 conserved areas including 47 miles of trails throughout town. These trails would enable users to safely travel throughout many areas of town, except for the fact that the crossings are unsafe narrow, slippery, broken, and lacking curbs or railings
- Crossings in Bolton Conservation areas need replacement to enable safe mobility for all users including hikers, joggers, cross country skiers, strollers, bikes, and horses
- Summer slipperiness is caused by slick green slime
- Winter slipperiness is caused by ice
- Focus on replacing crossings that are key for trail mobility in Bolton so users can travel safely around and between conservation areas

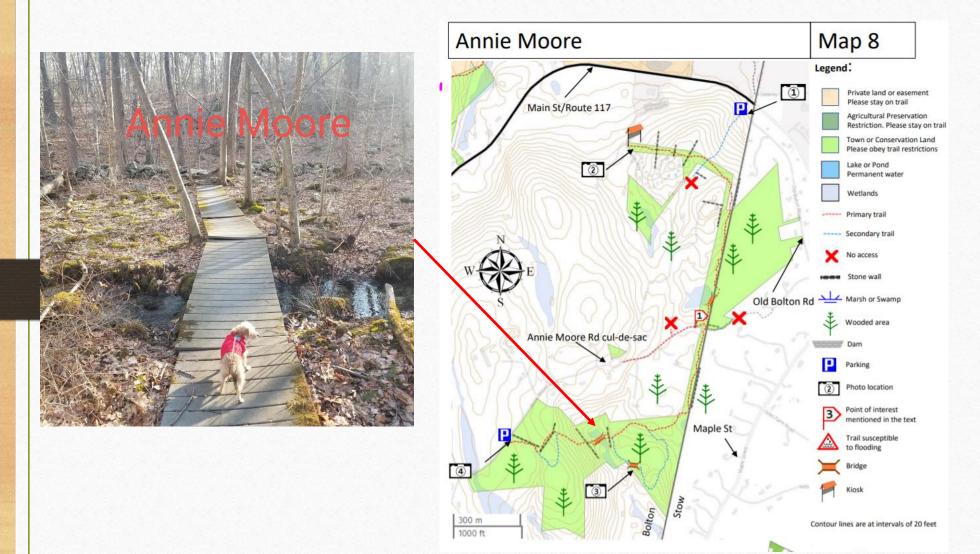
The Annie Moore boardwalk is in poor condition and is not safely passable. This trail is a key connector for residents and is not currently safe. Abutters, especially those with horses, are cut off from this conservation area by this crossing.

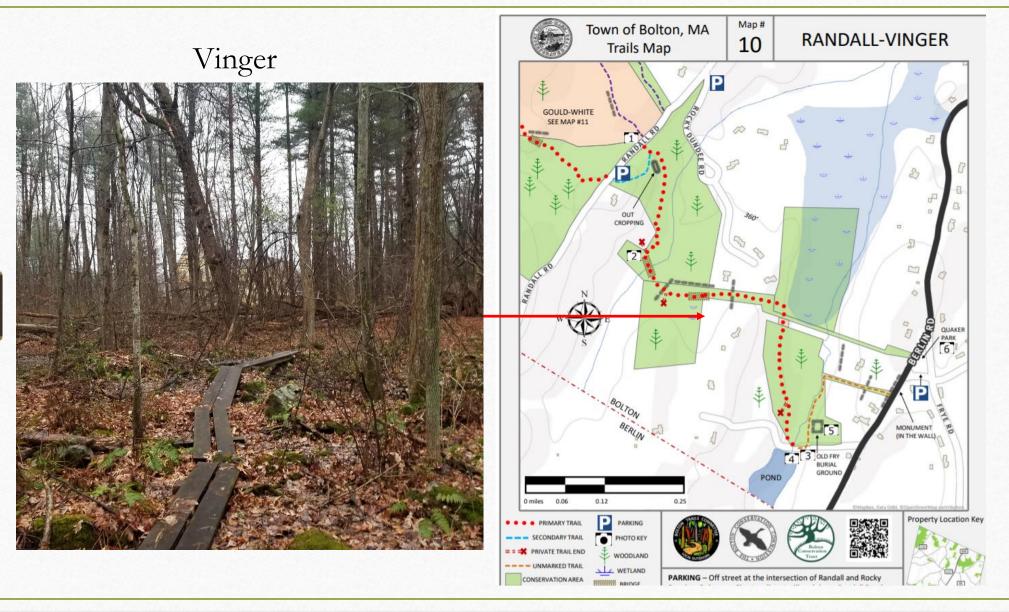
The existing bridge consists of planks (perched on stones), which are exceeding slippery at all seasons.

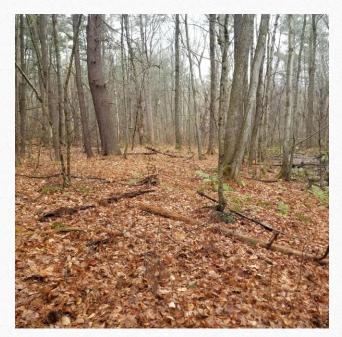
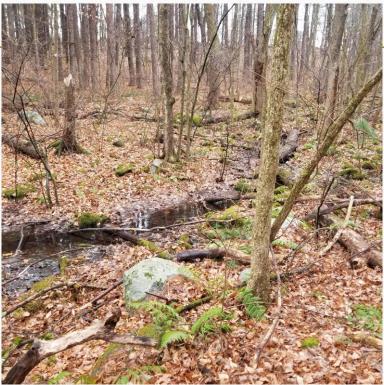
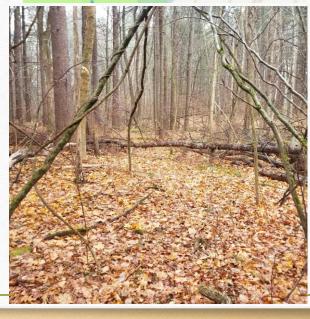
### Vinger new crossing

North new trail location

New crossing location

New south trail location->

Existing marsh crossing – to remain for adventurous hikers

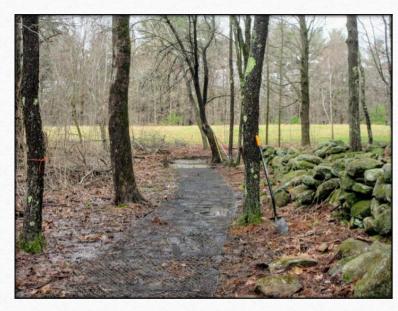
#### Triax

- Trail stabilization for wet areas: <a href="https://www.tensarcorp.com/Systems-and-Products/Tensar-Triax-geogrid">https://www.tensarcorp.com/Systems-and-Products/Tensar-Triax-geogrid</a>
  - Advanced geosynthetic product for ground stabilization
  - Most environmentally friendly solution
  - Zero ground disturbance
  - Easily work around obstacles like stumps and rocks
  - ABA (Architectural Barriers Act) compliant.
- 1 ½" faceted stone with ½" pea stone, or stump grindings
- Snowshoe effect
- https://photos.app.goo.gl/ZciUC3Vbf3f7zfHH8
- https://photos.app.goo.gl/9BNjQDZakN33J2Tq8
- Usage approved and implemented by other MA towns including, Groton, Hubbardston, and Millers Falls

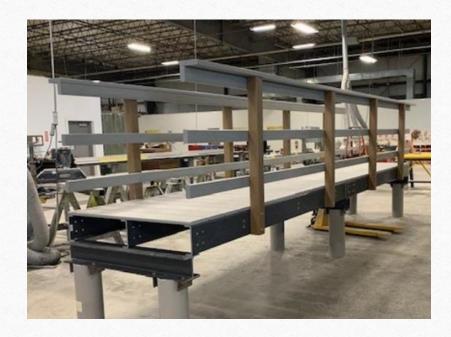
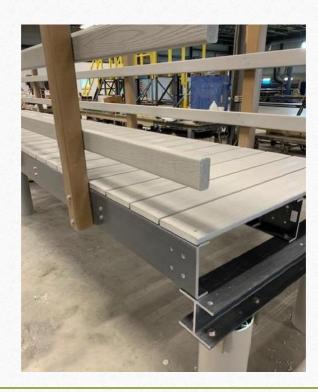
## Example of FRP Solution

- <u>Stream crossings</u> solve with FRP structures (Fiberglass-Reinforced Polymer), with FRP Molded Grating, GT116 geotextile, and Pea Gravel Decking Panels 75 year lifespan.
- Wet, mucky, unstable trail areas solve with Triax, an environmentally friendly advanced geo-synthetic solution for trail stabilization for wet, mucky areas, eliminating the need for slippery wooden boardwalks
